Springhill Access Statement

20 Springhill Road
Moneymore
Magherafelt
County Londonderry
BT45 7NQ

Access Statement completed December 2020

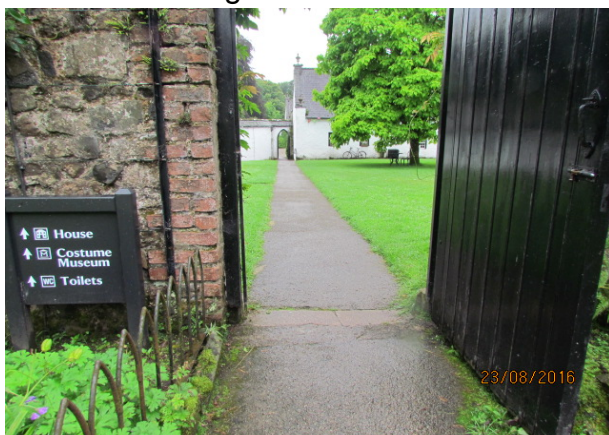
1. The distance from the car park and Visitor Centre to the house is 98 metres. There is a mild gradient downwards and it takes 5 minutes at a casual pace.

The route is marked with signs that lead to the front of the house for the start of the visitor's tour.

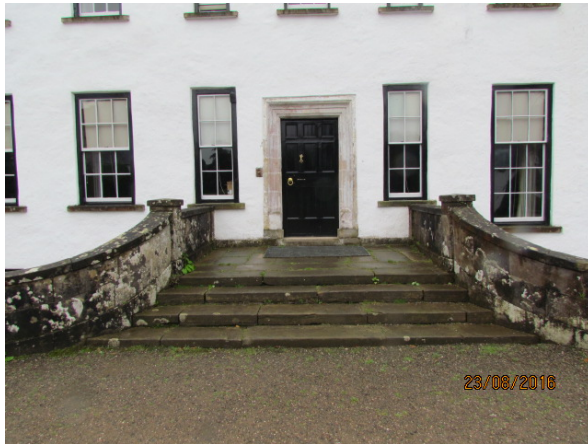
2. The surface in front of the house is lightly graveled.
3. The main entrance to the house has 4 steps and a final step leading into the Entrance Hall. It is level at the upper and lower areas of the steps. A ramp is not available at this point (see Q 5)

View of the front entrance into the house.

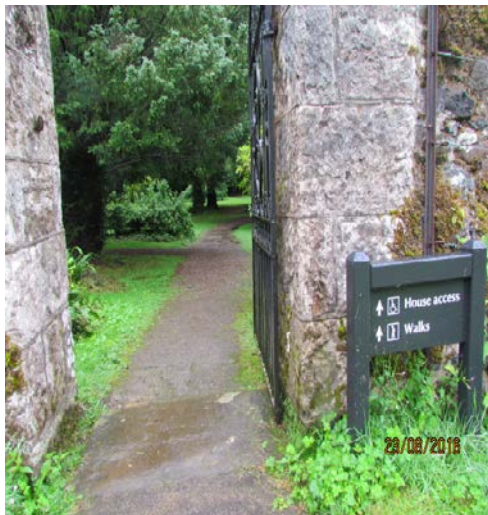
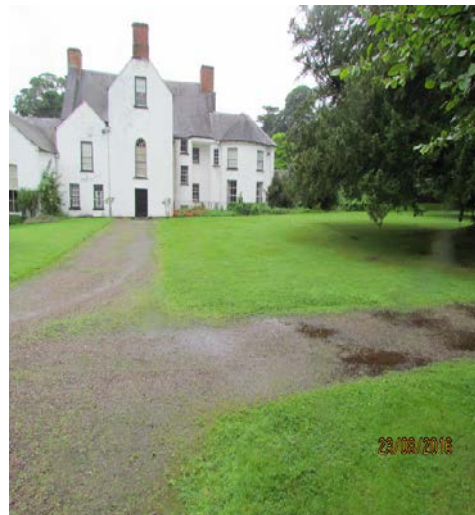
4. The entrance door is a manual door only. The door is 117cm wide and opens inwards and staff & volunteers help with opening and closing it.
5. There is a disabled access at the back of the house. Visitors will be shown the direction to go by staff in the Visitor Centre and the route is marked with signage. The distance to the back door is an extra 52 metres for the visitor to walk to avoid any steps. In total it is 150 metres from the Visitor Centre to the back of the house. The back door opens outwards and a member of staff will assist with this. The door is 115cm wide. The surface of the path to the back door is a mix of tarmac (40% of journey) and gravel (60% of journey).

Above left: View of the route to the back door which is sign-posted.
Above right: A view of the back door from distance.

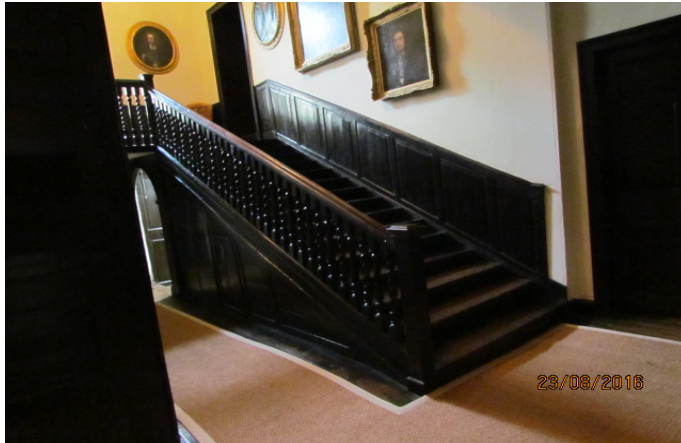
9. Access to the first floor is only accessible by stairs with handrails. There is a flight that leads to the middle landing area and another flight that leads to the upper landing area where the final room of the tour is located. First flight of stairs has 12 steps and the second has 8 steps. There is a photographic information booklet for visitors who cannot access the upper areas to give them an idea of what the upper areas contain.

View of the stairs that lead to the final room on the visitor journey

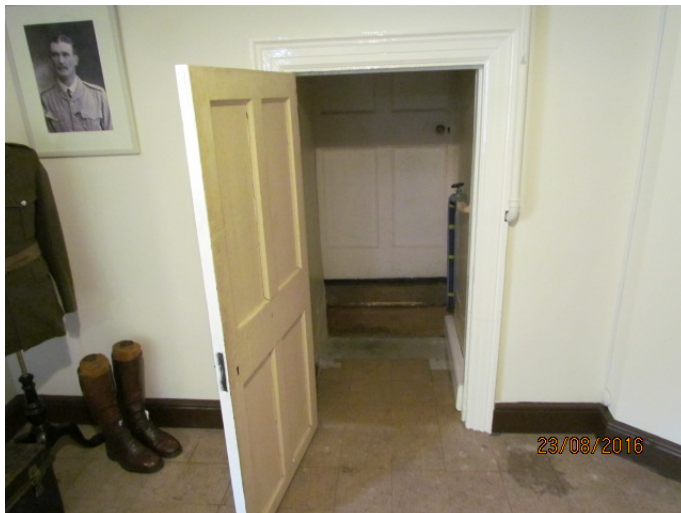
10. Coming from the Dining Room to the Butler's Pantry there is a narrow and low doorway where visitors are advised to be careful they don't bump their head. There is also a small step the visitor needs to manage. The open door in this photo is 156cm high and 72cm wide.

View of the low doorway from the Dining Room to the Butler's Pantry.

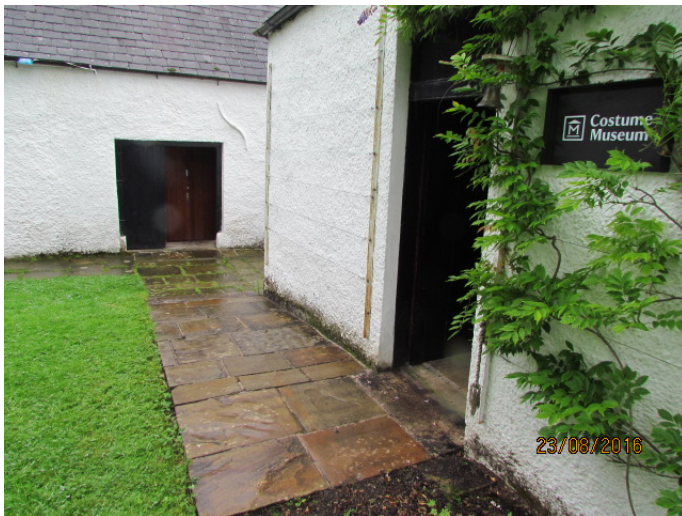
Photo of the flagstones outside the Costume Exhibition.

3. People can access the exhibition space by following the flagstones that take a turn to a slight gradient uphill until you get to the door of the Costume Exhibition.
4. The entrance door is manually operated and is generally open throughout the day so the visitor does not need to manoeuvre it. The door opens inwards. The width of the door is 95cm.
5. There is no other access/entrance door to the Costume Exhibition.
6. The Costume Exhibition area is not furnished therefore, there may be echoes within this space if there are many people inside.
7. The area is lit by fluorescent bulbs and some strip lighting. There is no natural light in the areas past the first part of the exhibition. This means that $\frac{3}{4}$ of the space has artificial light.
8. There is space to turn a wheelchair in the Costume Exhibition.
